Manhole Inspection Summary

Manhole # S33M1_025MH

Location Address: **Terra Firma Road** Cross Street: **Cherry Hill Road**

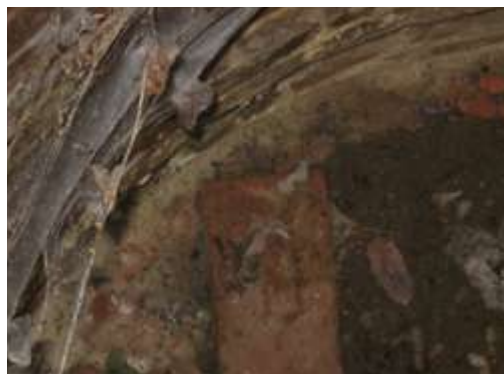
Defect 2

debris on bench

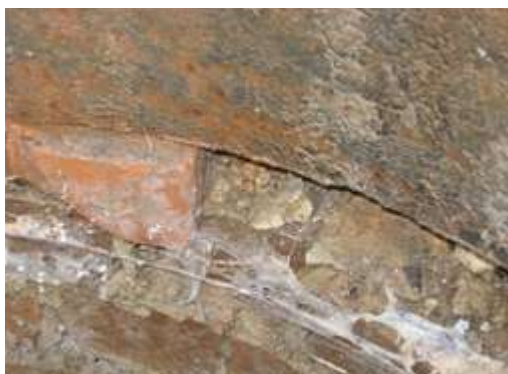
Defect 1

Chimney / Frame Adjustment ☒ Exists Material: **Brick** ☐ Parged Height: **8** (in.)
Condition: ☐ Sound ☐ Cracked ☐ Root Intrusion ☒ **Loose Brick** ☐ Deteriorated
Infiltration: ☒ None ☐ Joint ☐ Cracks ☐ Mortar ☐ Roots ☐ Wall

loose bricks on chimney

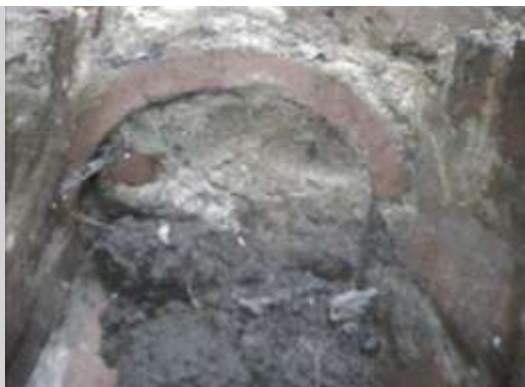
6 O'Clock Inflow

Comments **Could not accurately measure influent pipe @ 6 O'Clock due to blockage**

8 in. Circular Service Sewer
Pipe In @ 6 O'Clock

Connects To: **Stub connection / abandoned**
